**STRUCTURAL CONDITIONS ASSESSMENT
FORMER GILFORD BUTLER SCHOOL
PROPOSED COMMUNITY CENTER & LIBRARY
SOUTH THOMASTON, MAINE**

Prepared for
Town of South Thomaston

Report Issue Date: October 3, 2019

Project No. 19-180

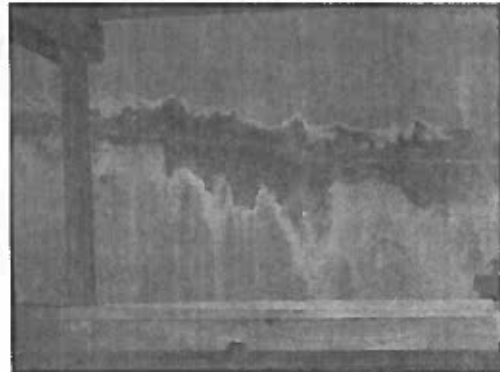
There are several vertical cracks in the south foundation wall, and similar cracks around the entry at the north wall. These appear to have been maintained and do not appear to be structurally significant at this time, although ongoing maintenance to prevent water infiltration may be required. The taller walls at the north of the building appear to have started to cure during placement which resulted in irregular cold joints in the placement (which appear as uneven horizontal seams). There is evidence that water has infiltrated through the wall at many of these cracks in the past and may still be occurring at some cracks. There is also evidence that water either infiltrates through the walls at other locations or may come up through the joint between the wall and the slab. There were a few puddles of water along the east wall in the Cafeteria space during our visit, which may have been due to water infiltrating through the foundation, although the cause was not evident.

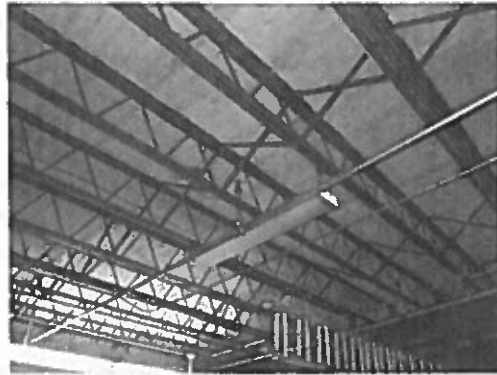
Both the open-web steel joists and the steel W-beams show signs of corrosion where they intersect the concrete foundation walls. Some locations have more corrosion than others. Corrosion appeared to be mild to moderate. No severe corrosion was observed.

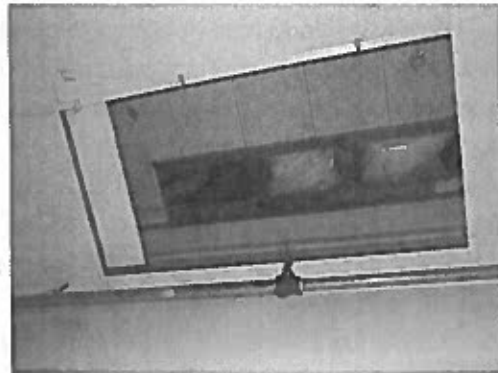
The existing roof framing appears to be 5 1/4" x 13 1/4" Western Fir rafters spaced approximately 7' - 4 3/4" on-center spanning approximately 24'-4" east-west between the exterior walls and the center Corridor walls. The roof framing over the Corridor was not exposed, but is assumed to be similar although it has a much smaller span. Only a small section of a few rafters was exposed, so further observation of the structural roof system was limited.

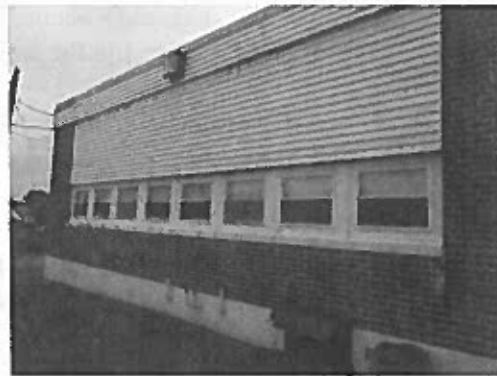
The CMU block, as exposed on the interior, appeared to be in satisfactory condition. The brick masonry façade on the exterior is generally in good condition although there are localized areas

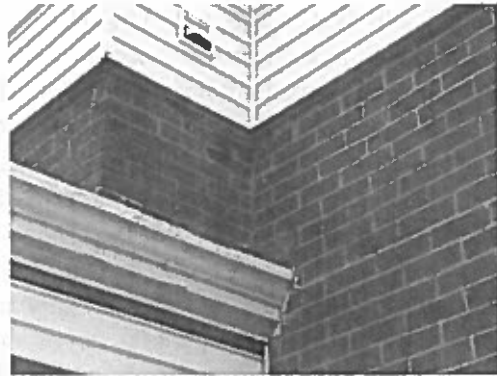
of degradation and/or shifting. In particular, the brick near the south corner of the entrance on the west façade, above the cantilevered roof, appears to have shifted inward. Step cracks in brick masonry joints and minor shifting were observed around the north and south entries. A brick was loose and removable by hand in the second brick course directly west of the south entry. A few bricks, particularly near the entry, had surface spalling which may be associated with chloride exposure if salt was regularly spread on the adjacent stoop in winter. Some bricks were observed to be cracked through the brick itself (as opposed to in the joint) which is often due to moisture freezing in the brick material, indicating a possible moisture issue or water penetration.

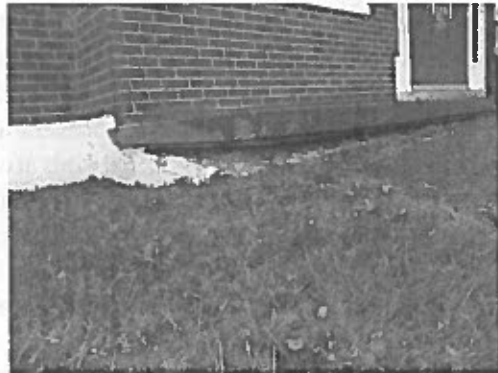
The concrete stoop and ramp at the west (front) entry is in marginal condition. The stoop appears to be a slab on grade placed on a perimeter frost wall. The stoop has several intermittent cracks running east-west which, when considering the long narrow shape of the stoop and the lack of contraction joints, are likely due to shrinkage. The stoop surface appears to be newer than the original frost wall below. The top of the frost wall appears to have substantial material degradation, which, if left unaddressed, will ultimately undermine the stoop slab and cause cracking and/or differential movement.

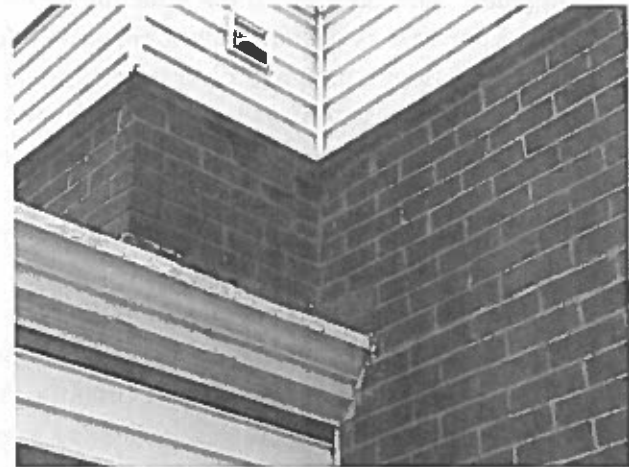
4) Exterior – Masonry degradation at south end of entry roof canopy; localized masonry repairs are required

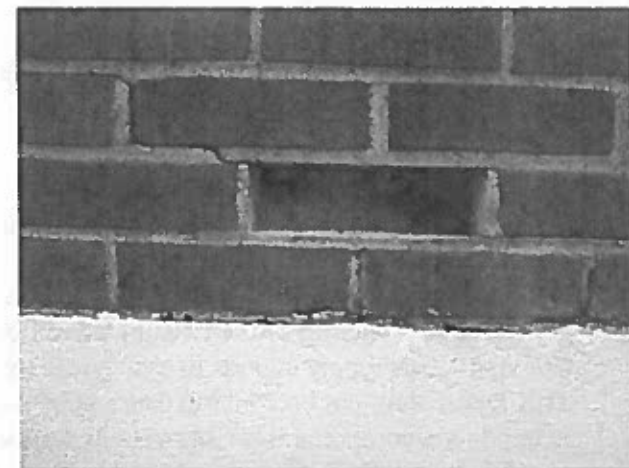
6) Exterior – Masonry degradation west of south entry; brick was loose and could be removed by hand (was replaced); step cracks in joints

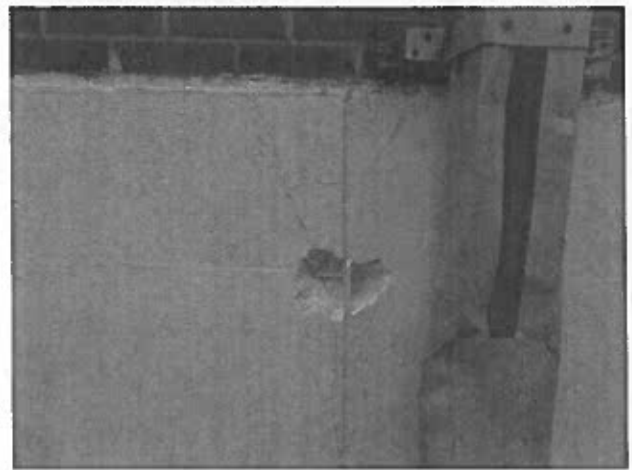
10) Exterior – East façade; Crack at expansion joint with horizontal bar showing; paint is protecting; localized concrete repairs required

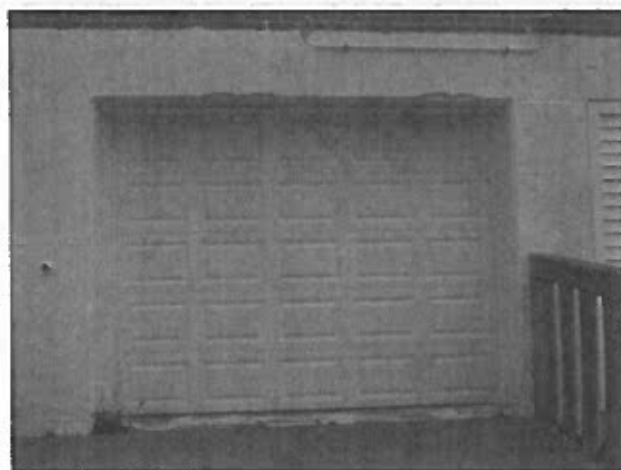
11) Exterior – East façade; Damage at overhead doors; paint is protecting; localized concrete repairs may be required

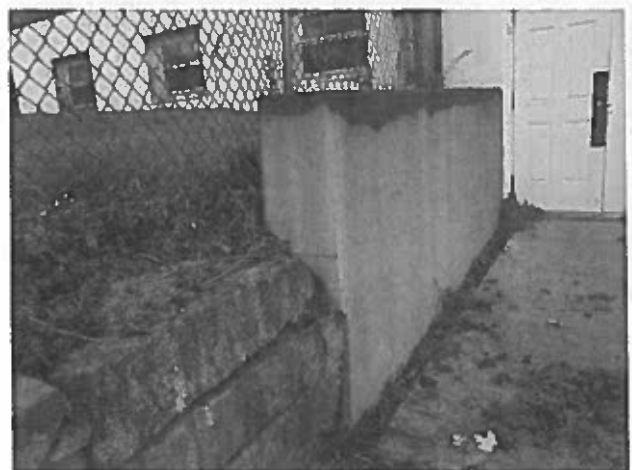
The exterior retaining wall intersecting the east wall is composed of a section of cast-in-place concrete closest to the foundation wall, then transitions to a stacked stone wall beyond. The concrete retaining wall appears plumb and in good material condition. The stacked stone wall appears to be shifting/leaning inward/northward at the top.

12) Exterior – Retaining wall at rear elevation change; stone wall is out of plumb and shifting; concrete wall is in good condition

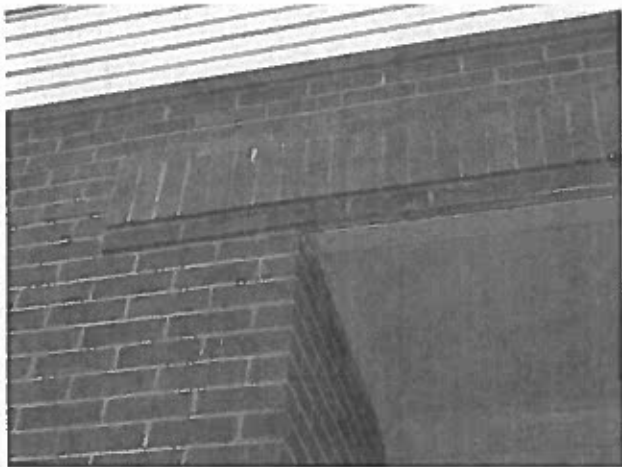
15) Exterior – Masonry degradation/shifting at east side of north entry opening; localized masonry repairs are required

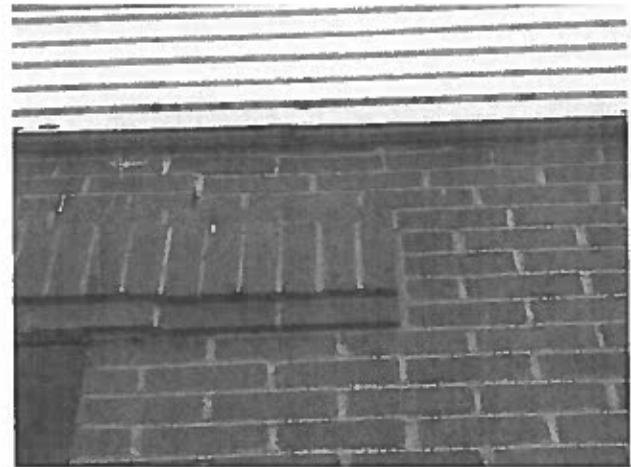
16) Exterior – Masonry degradation/shifting at west side of north entry opening; localized masonry repairs are required

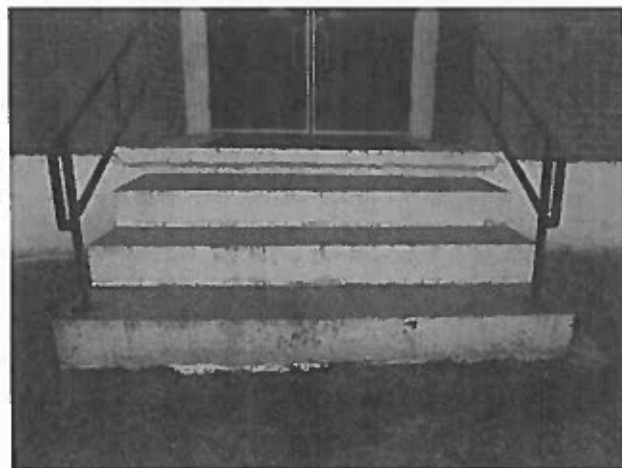
The stairs at the north entry appear to rest on grade and do not appear to have frost protection. Seasonal shifting of the steps may occur. Soil at the base of the steps appears to be eroding which could eventually undermine the stairs.

17) Exterior – North entry stoop is undermined and lacks frost protection

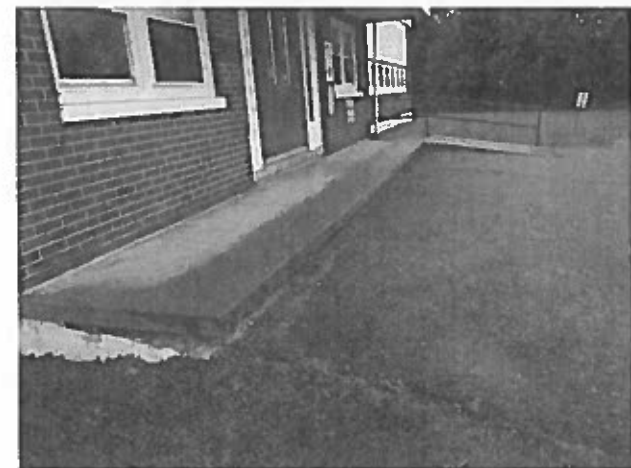
18) Exterior – West (main) entry stoop bears on degrading frost wall below

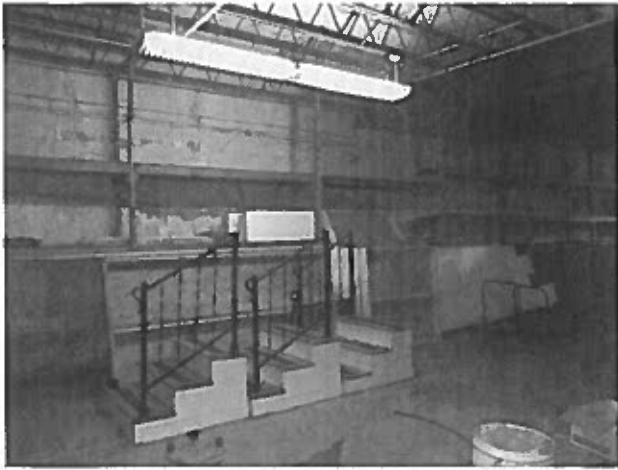
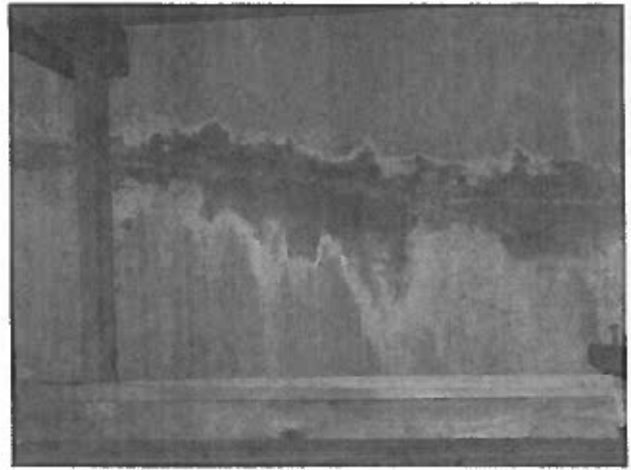
25) Interior Foundation – High bay area foundation has evidence of concrete setting during placement causing horizontal seams

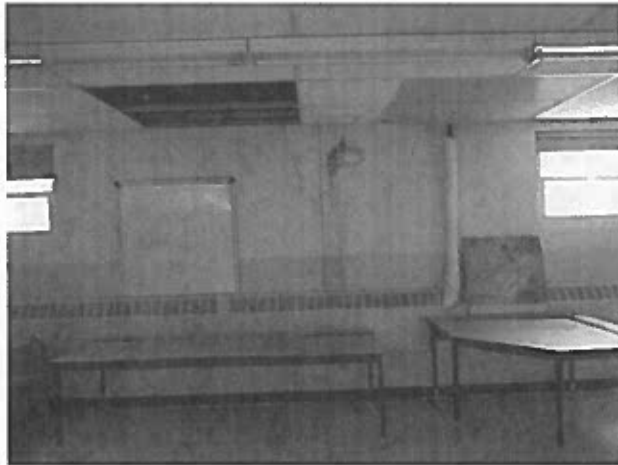
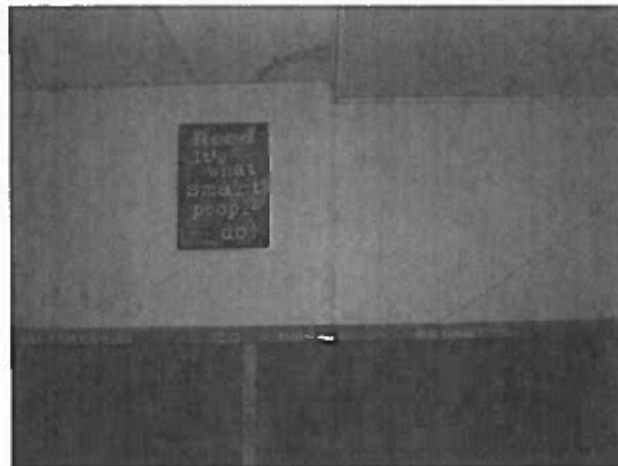
27) Interior Foundation – Cafeteria area walls are in sound condition with some vertical cracks that have been maintained; water seepage is evident

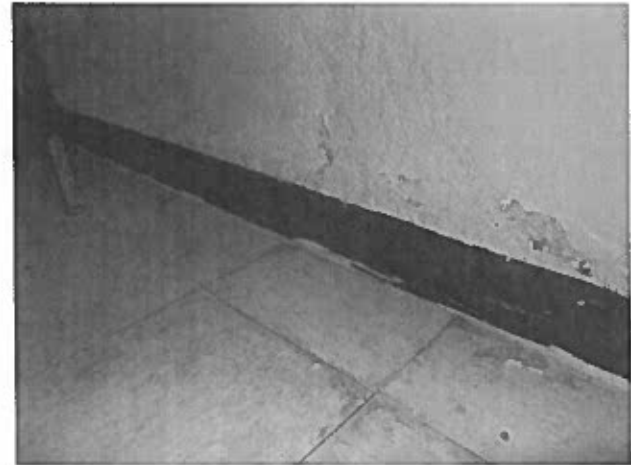
28) Interior Foundation – East cafeteria area wall has water penetration or condensation issue; puddles were evident on the floors near the wall

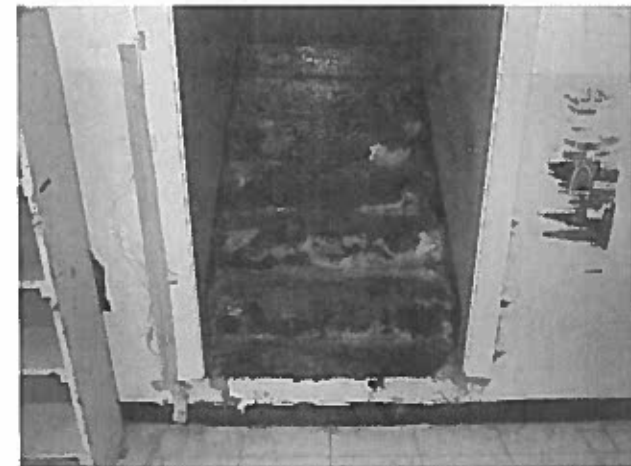
The concrete steps at the enclosed stair at the south end of the east wall are in poor condition. Spalling and material degradation is present and is likely due to water infiltration.

30) Interior Foundation – Stairs are degraded at exit stair near southeast corner of the building

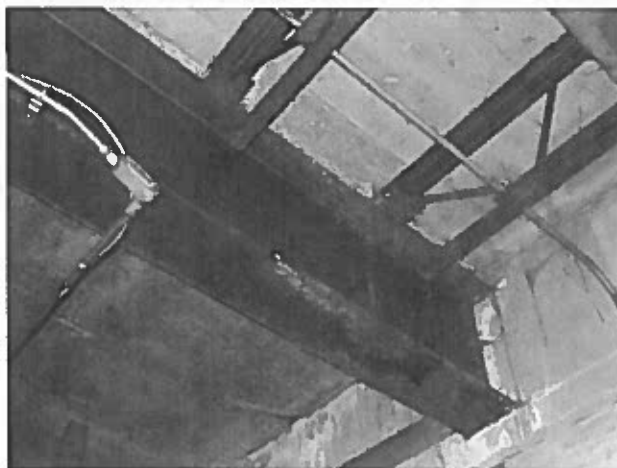
35) First floor framing – Typical steel beam condition at foundation wall; some corrosion is present

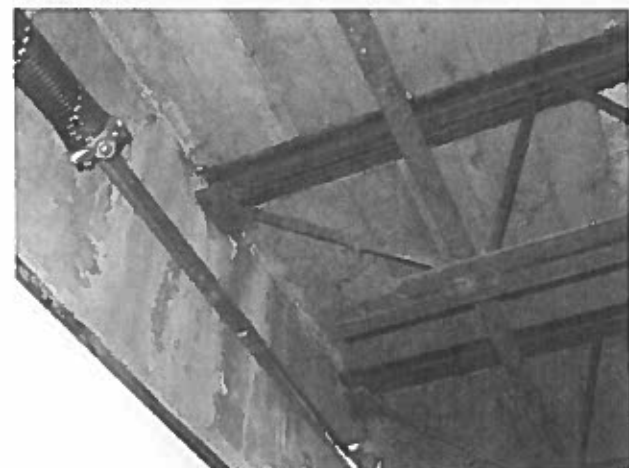
36) First floor framing – Typical open web steel joists at foundation wall; some corrosion is present

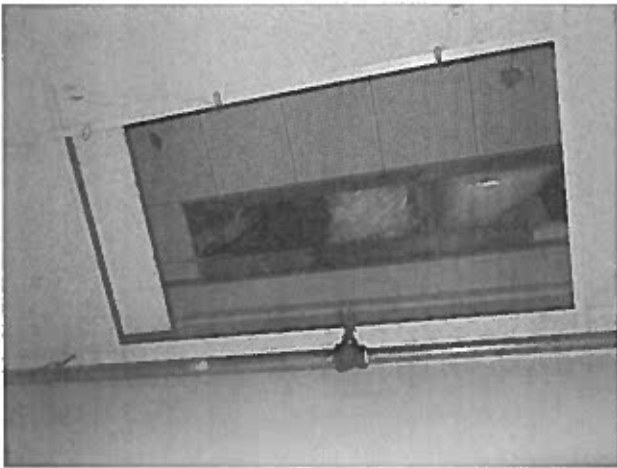
Based on our analysis, the roof timbers appear to be undersized for current design snow loads, plus the dead loads applied by the roof, original ceiling and newer dropped ceiling. Calculations indicate the timbers are approximately 25 to 35 percent overstressed in bending. In addition, the stiffness of the timbers does not appear to be adequate to meet current serviceability/deflection criteria ($L/360$) for most directly-applied ceilings (drywall, plaster, etc.).

37) Roof framing – Timber rafters were exposed in select locations; timbers match original specification
